SILVER CREEK STREAM IMPROVEMENT

A PROGRESS REPORT ON PROJECT F-16-D  
FOR 1955-56

By  
Robert B. Irving  
Fisheries Biologist

STATE OF IDAHO  
DEPARTMENT OF FISH AND GAME  
Boise, Idaho  
December 31, 1956

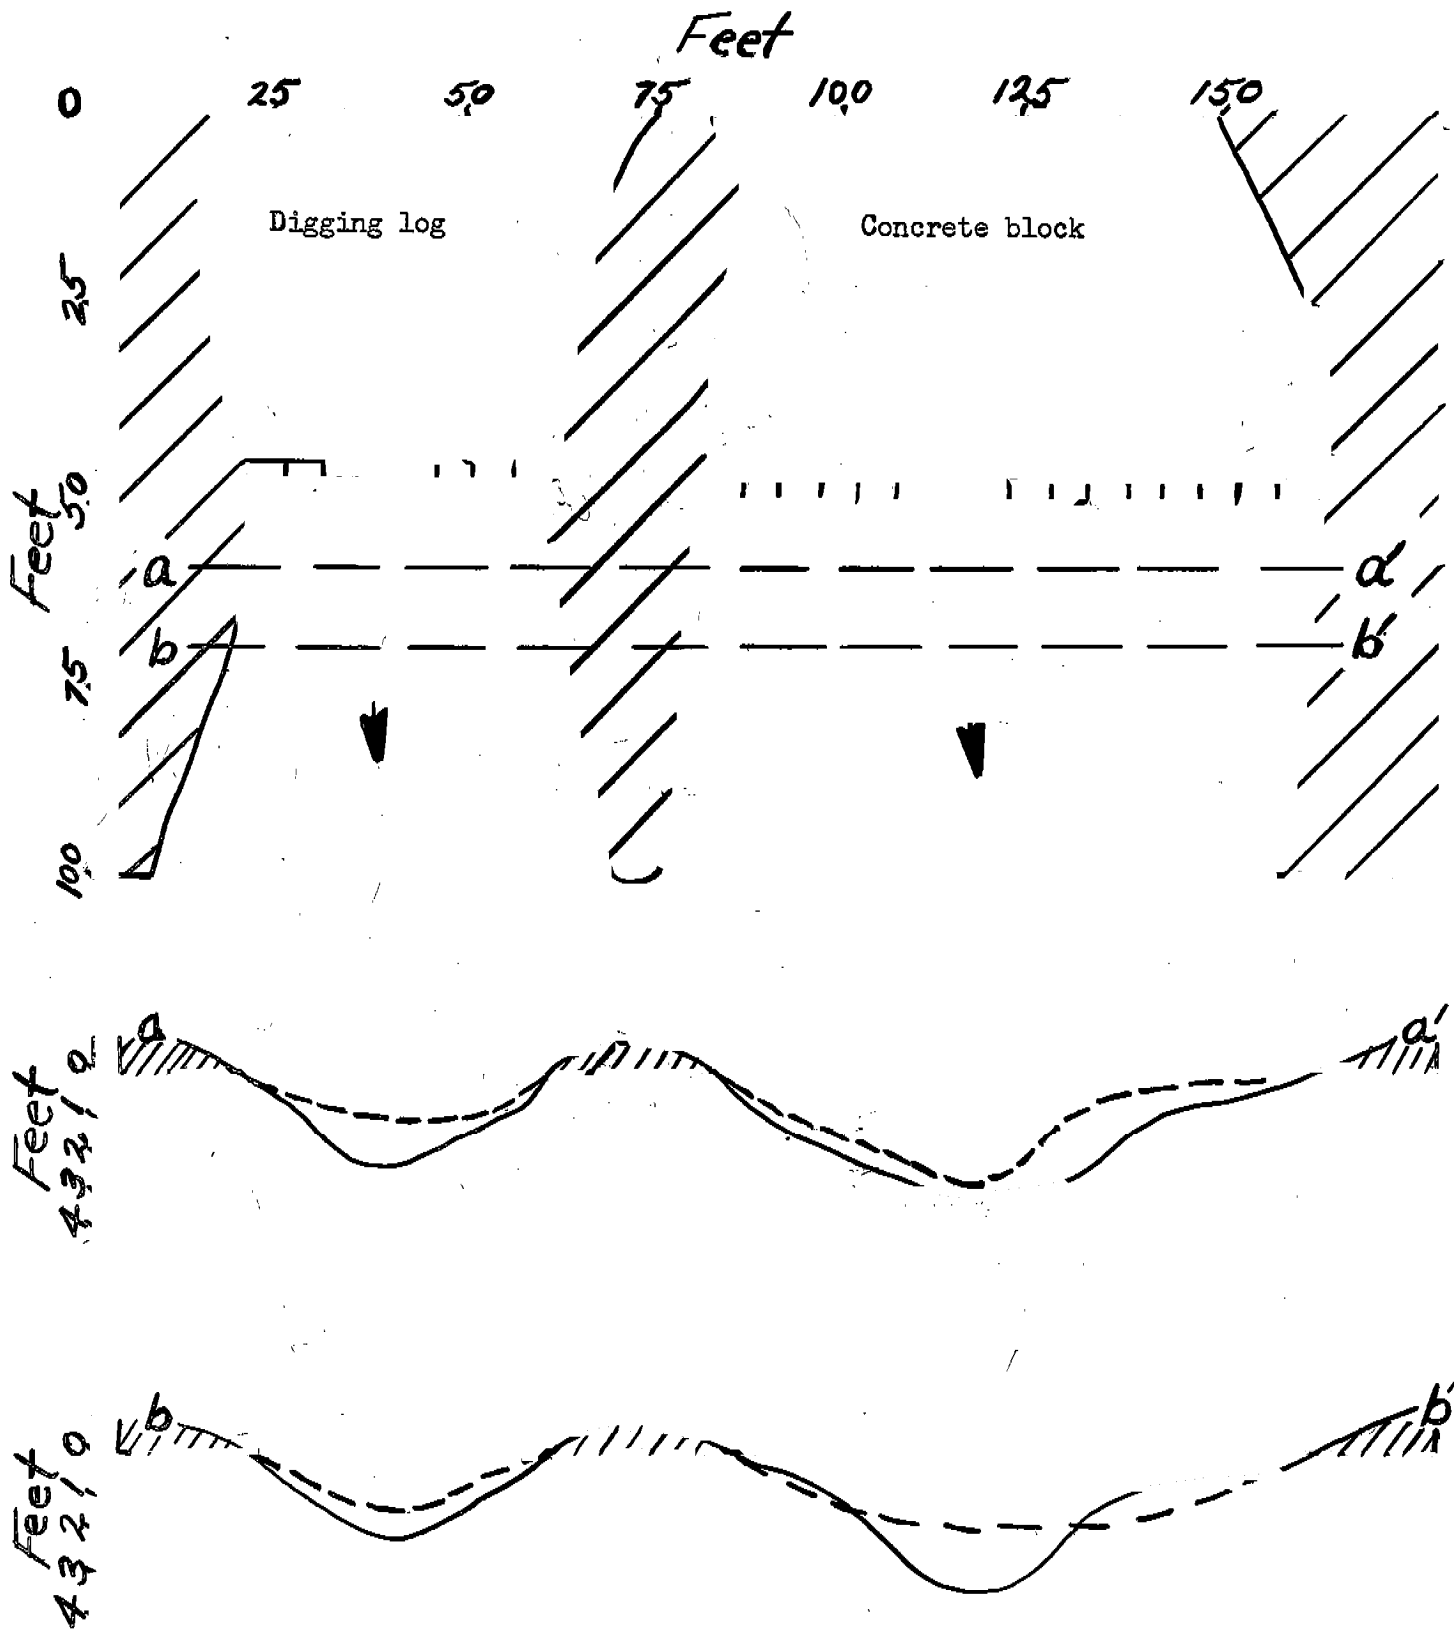
After the log was placed in the west channel, it appeared that little digging action would occur; therefore, several concrete blocks were placed on the upstream face of the log to further constrict the flow and increase the digging action. By November, 1956, as a result of a raise in water levels plus digging action, the pool below the digging log structure had increased in depth from 12 inches to 30 inches. (Figure 2).

Within a week after the concrete-block structure had been installed at Grove Creek #1, a large hole had washed under the center blocks of the structure (Plate 2). Corrective action was taken by removing the base and common blocks above the hole and adding common blocks on either side to restrict the flow to the open section in the center of the stream. By November, 1956, as a result of a raise in water levels plus digging action, the pool below the structure had enlarged and increased in depth from 30 to 42 inches (Figure 2).

Figure 2. Grove Creek installation #1. Dotted lines show cross-section of stream bottom prior to installation of structures in October, 1955 and solid lines show cross-section of stream bottom in November, 1956.

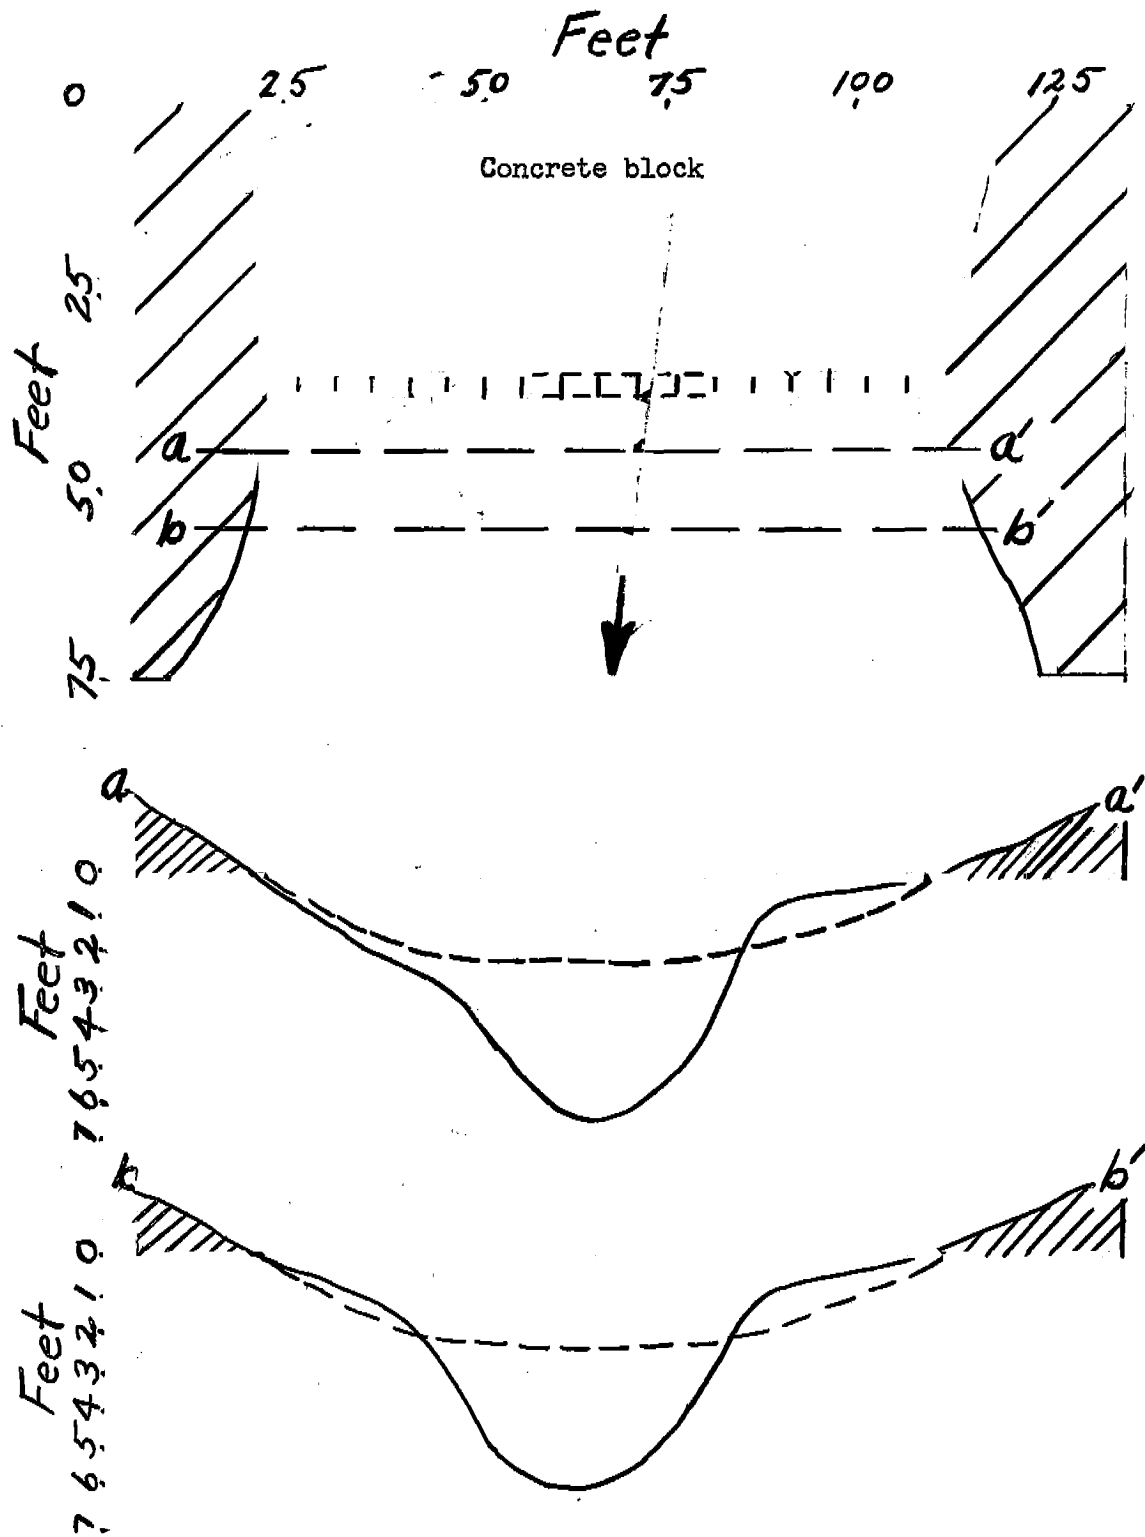
Grove Creek installation #2. A concrete-block structure was installed at this site in October, 1956. Digging action began immediately, in fact, several loads of gravel and boulders were placed on the upstream side of the structure to prevent it from washing out before it could be completed. Within two weeks, the pool below the structure had enlarged and increased in depth from 25 inches to 74 inches. (Figure 3).

Figure 3. Grove Creek installation #2. Dotted lines show cross-section of stream bottom prior to installation of structure in October, 1956 and solid lines show cross-section of stream bottom in November, 1956.

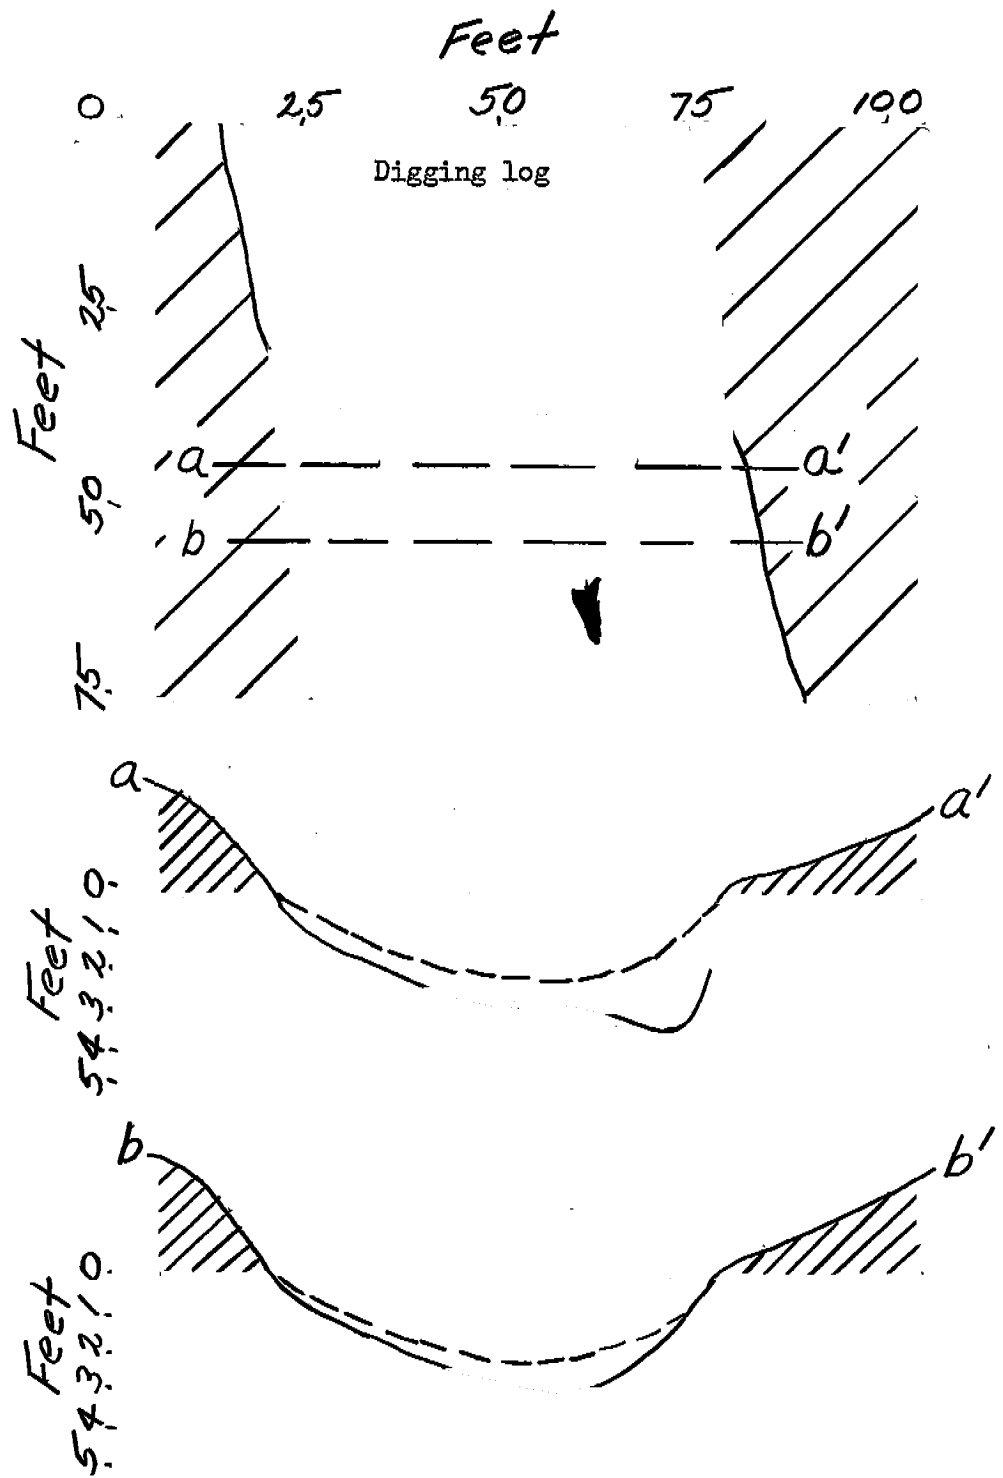
Grove Creek installation #3. A digging log structure was installed at this site in October, 1955. By November, 1956, as a result of digging action, the pool below the structure had enlarged and increased in depth from 25 inches to 38 inches (Plate 4, and Figure 4).

Figure 4. Grove Creek installation #3. Dotted lines show cross-section of stream prior to installation of structure in October, 1955 and solid lines show cross-section of stream bottom in November, 1956.

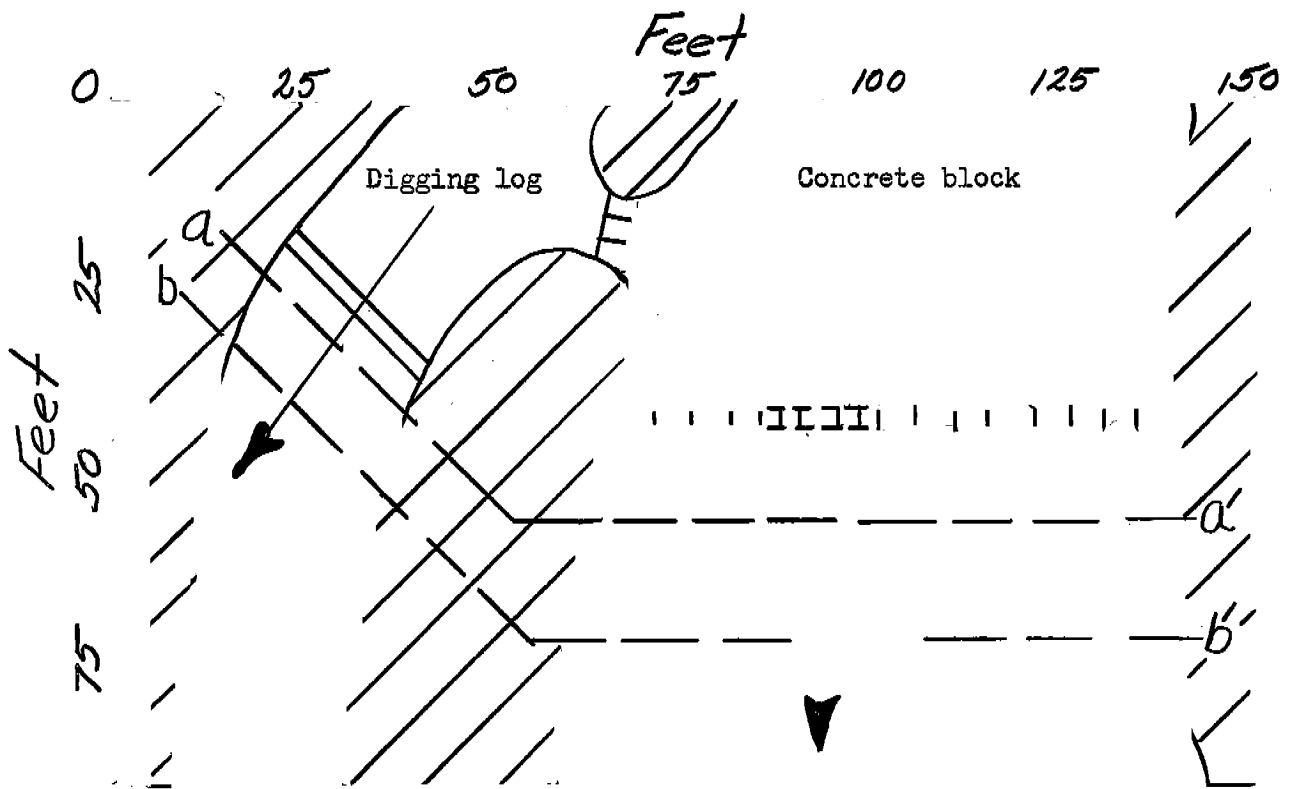
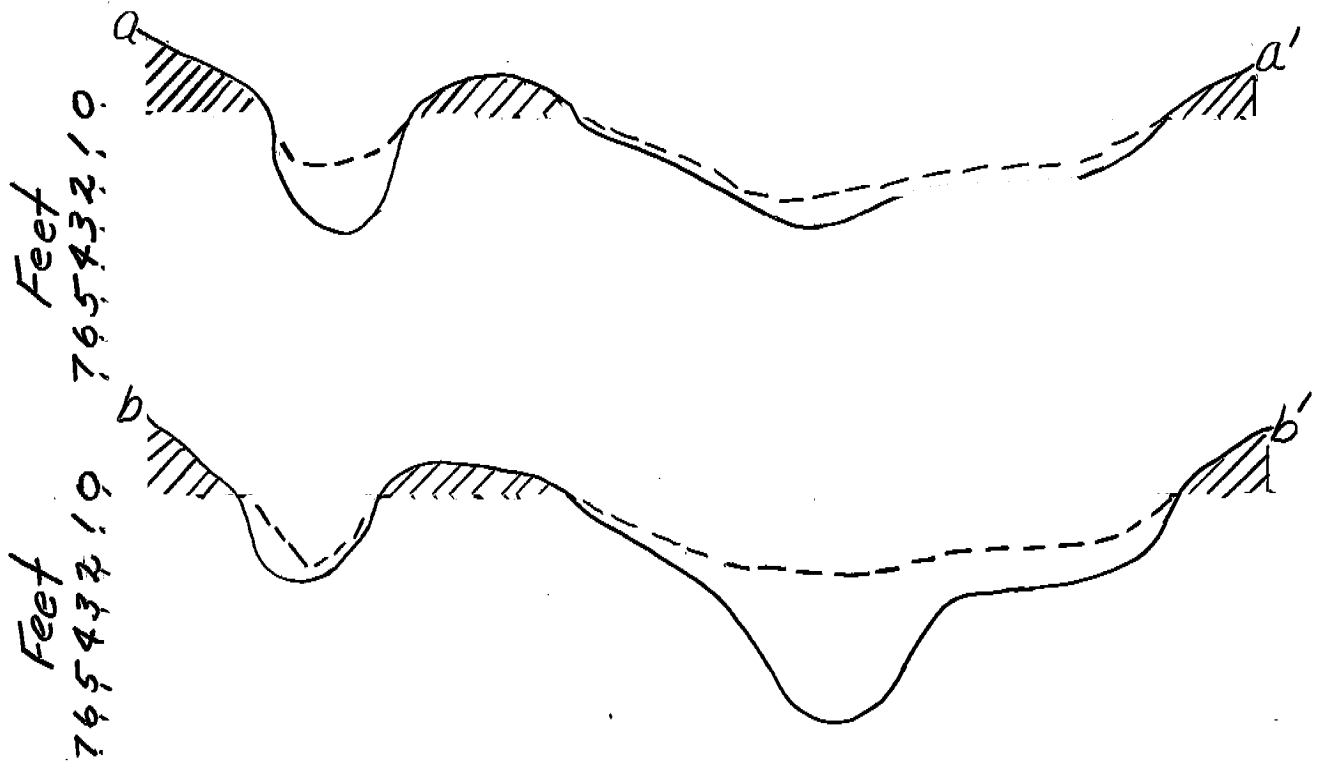
By November, 1956, the pool below the digging-log structure, as a result of a raise in water levels plus digging action, had enlarged and increased in depth from 20 to 39 inches (Figure 5).

After the concrete-block structure was installed at this site in October, 1955, several loads of gravel were placed along the upstream face of the base blocks to prevent washing beneath the structure. Within a week after this structure had been completed, the pool below had deepened to 50 inches and by November, 1956, as a result of a raise in water levels plus digging action, the pool was much enlarged and had increased in depth from the original 29 inches to 72 inches (Figure 5).

Figure 5. Grove Creek installation #4. Dotted lines show cross-section of stream bottom prior to installation of digging log and concrete block structures in October, 1955. Solid lines show cross-section of stream bottom in November, 1956.

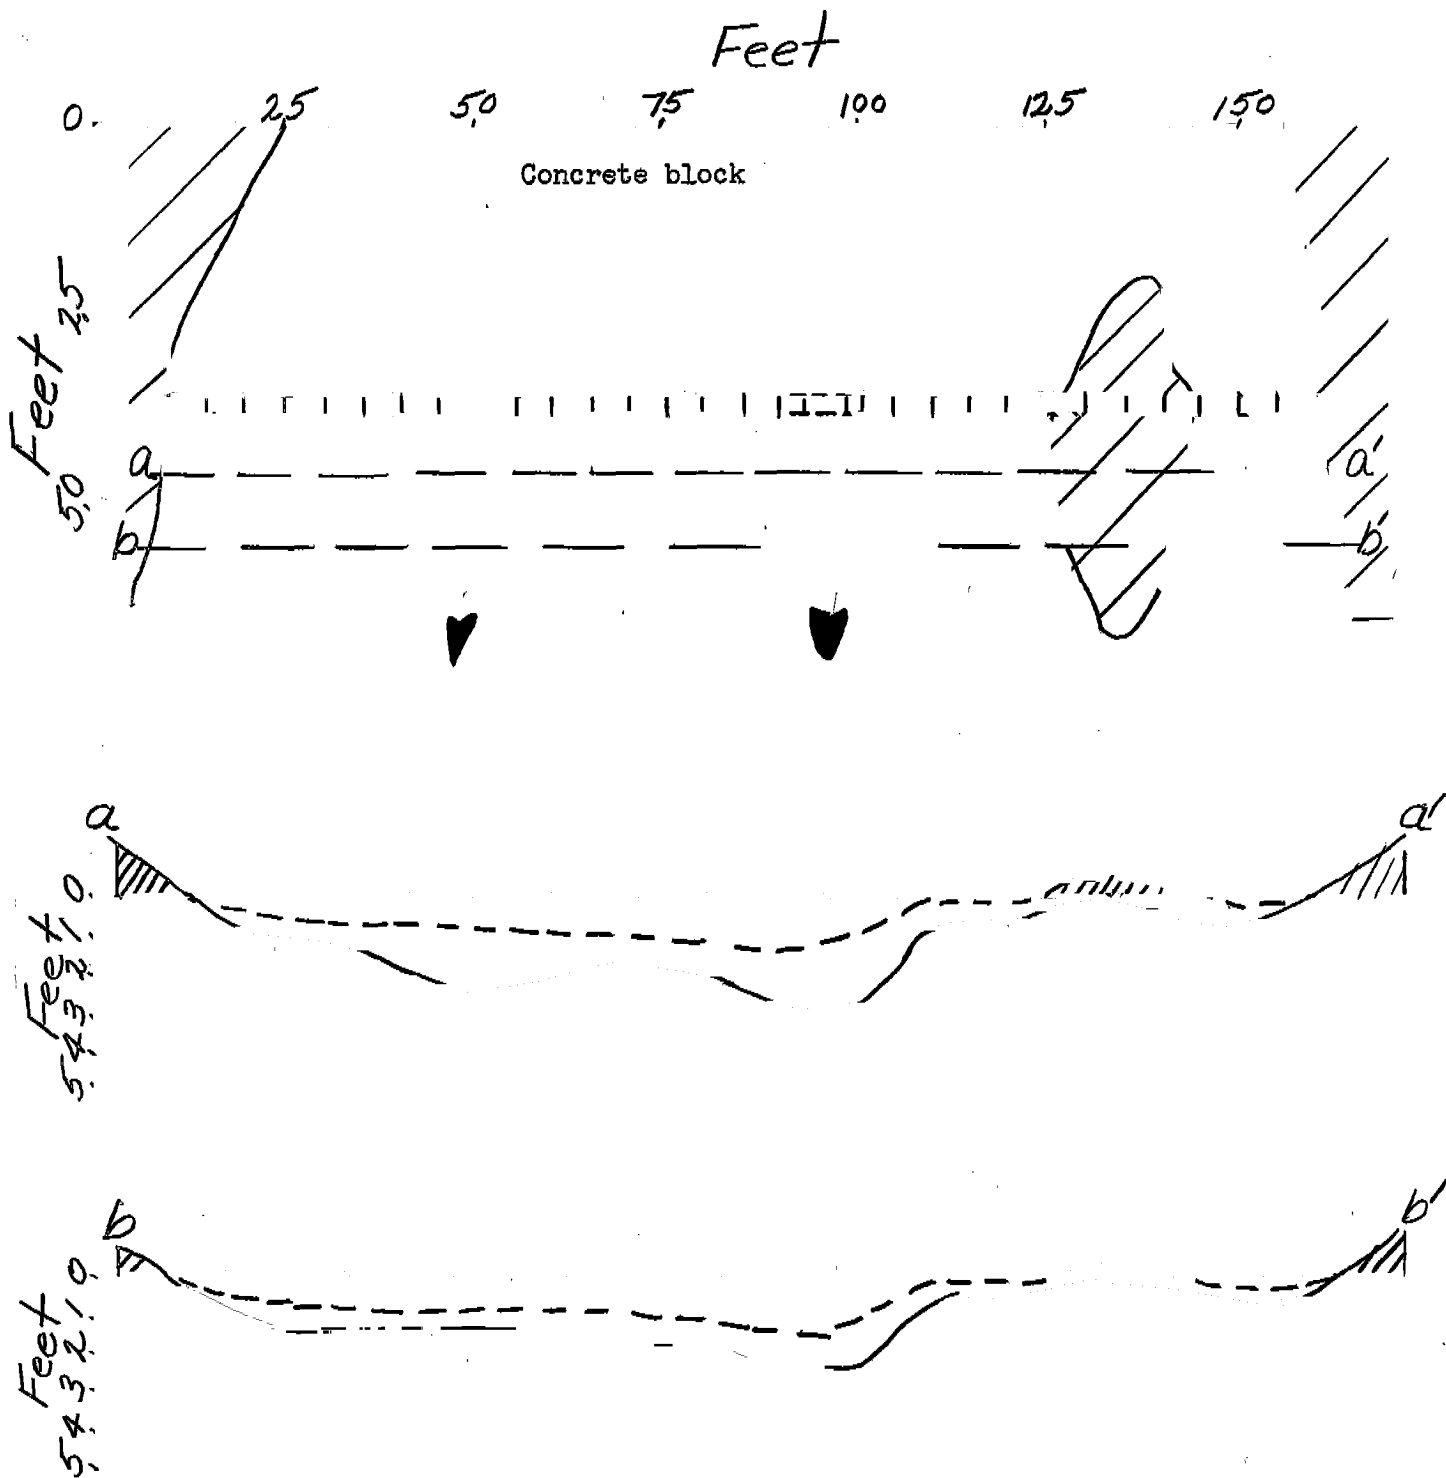
Grove Creek installation #5. The concrete-block structure installed at this site in October, 1955 is 150 feet in length: Grove Creek proper is 100 feet in width and the low bank on the east side is 50 feet in width. By May of 1956, a large hole had washed under the base blocks in the channel opening on the west side of the structure. The base blocks and common blocks above this hole were removed and additional common blocks were placed on the structure to restrict the flow to the two openings. By November, 1956, the pools below the west and east openings in the structure, as a result of a raise in water levels plus digging action, had enlarged and increased in depth from 12 to 30 inches and 17 to 36 inches, respectively (Figure 6).

Figure 6. Grove Creek installation #5. Dotted lines show cross-section of stream bottom prior to installation of concrete-block structure in October, 1955. Solid lines show cross-section of stream bottom in November, 1956.

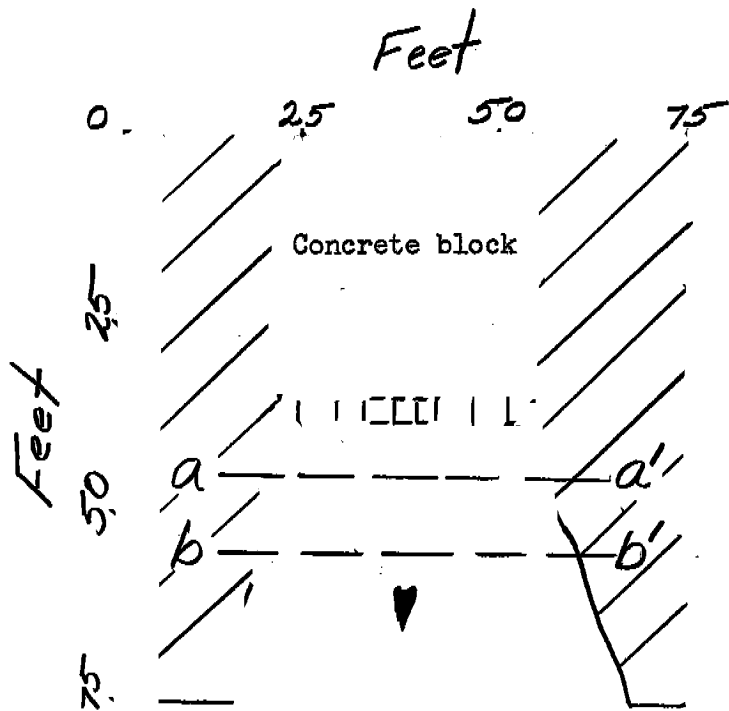
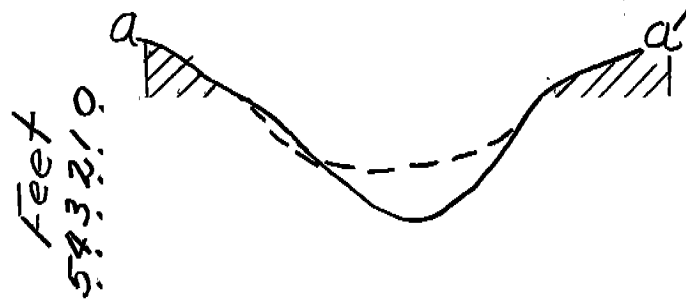
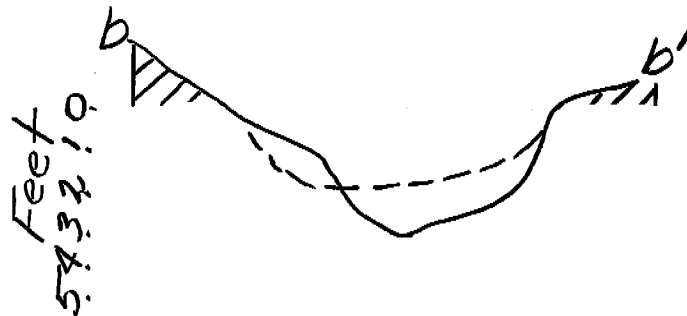
Loving Creek installation #1. A concrete-block structure was installed at this site in October 1956. By November, 1956, the pool below the structure, as a result of digging action, had enlarged and increased in depth from 24 to 37 inches (Plate 38 and Figure 7).

Figure 7. Loving Creek installation #1. Dotted lines show cross-section of stream bottom prior to installation of concrete-block structure in October, 1956. Solid lines show cross-section of stream bottom in November, 1956.

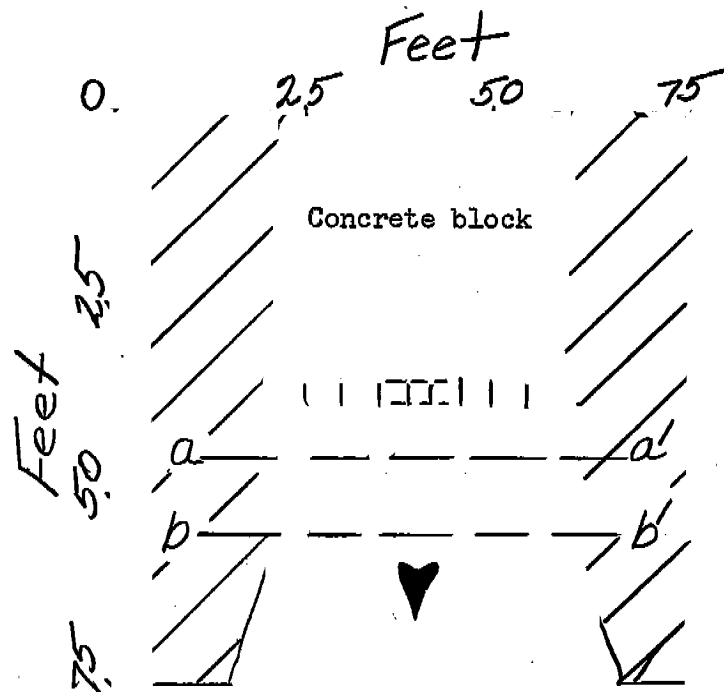
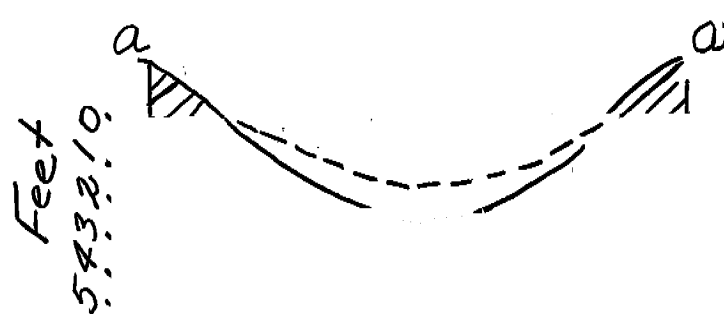
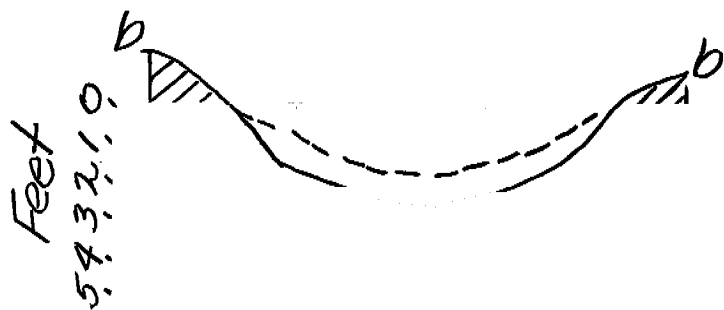
Loving Creek installation #2. A concrete-block structure was installed at this site in October, 1956. By November 1956, the pool below the structure, as a result of digging action, had enlarged and increased in depth from 20 to 29 inches (Figure 8).

Figure 8. Loving Creek installation #2. Dotted lines show cross-section of stream bottom prior to installation of concrete-block structure in October, 1956. Solid lines show cross-section of stream bottom in November, 1956.

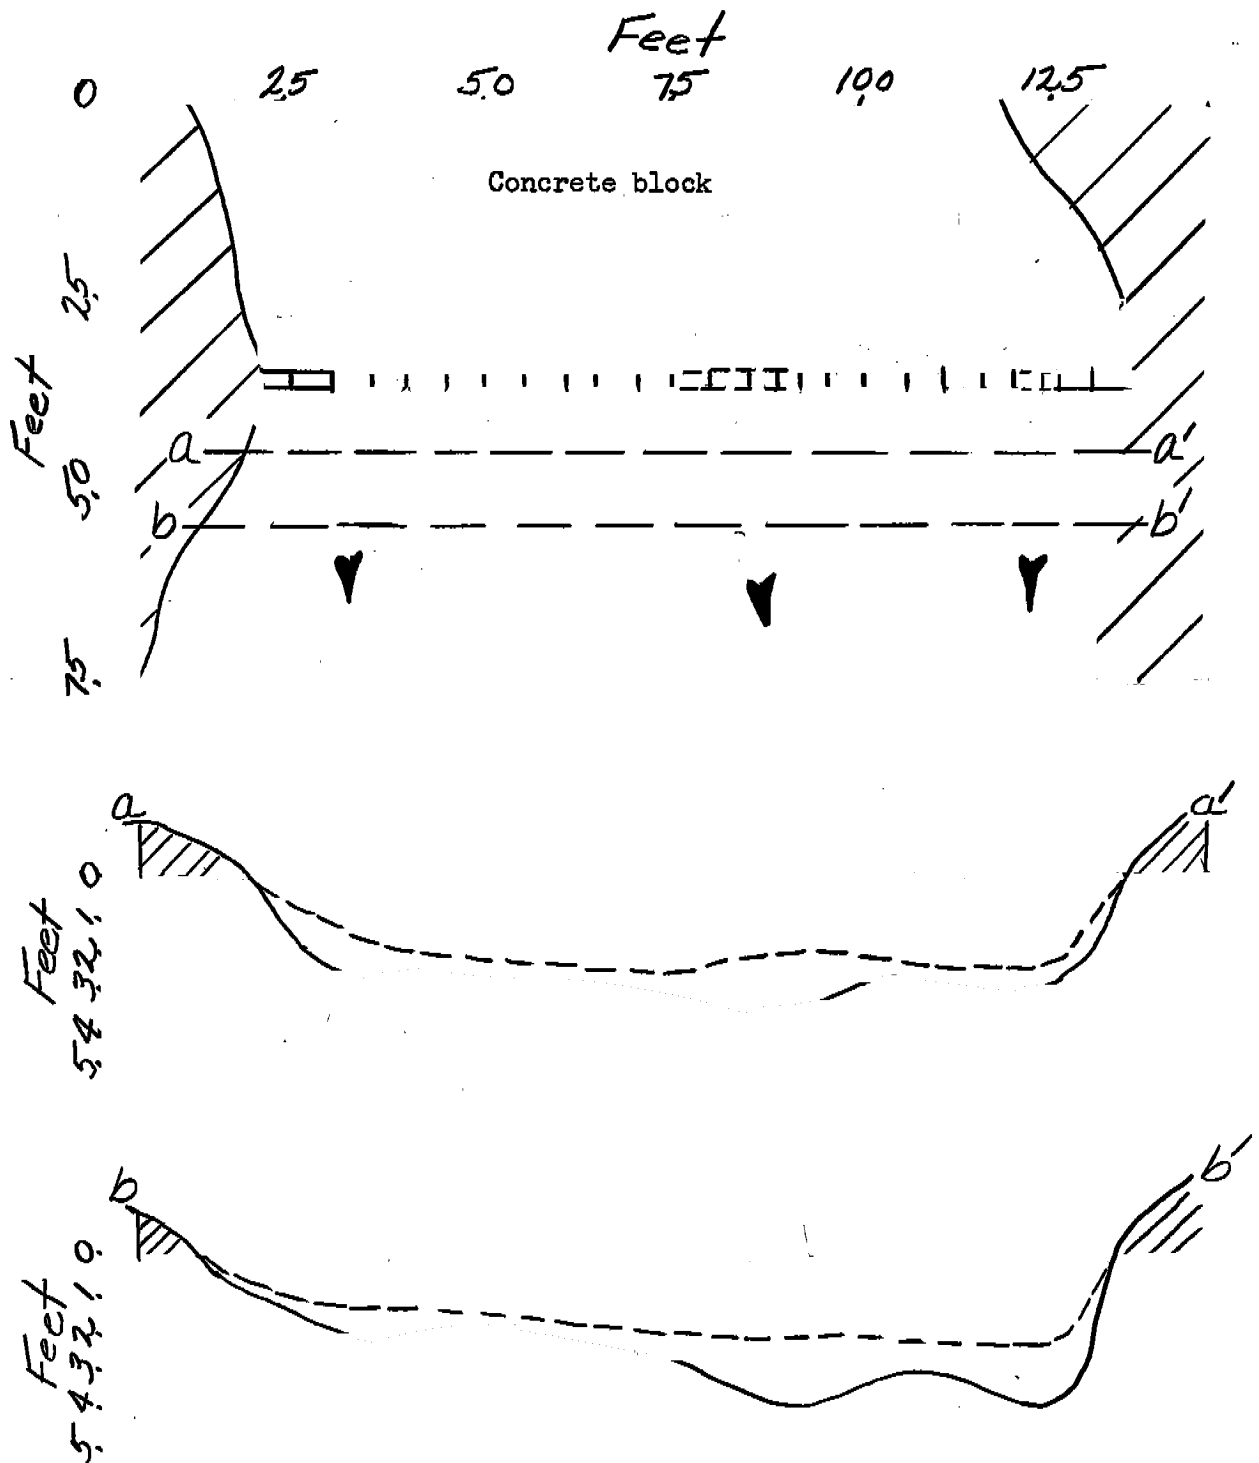
Silver Creek installation #1. The concrete-block structure installed in October, 1955 at this site is 120 feet in length. Initially, this structure was one base block and two common blocks in height except for the three openings which were one base block and one common block high (Plate 6). By May, 1955, a hole had washed under the base blocks at the opening on the south side. The common and base blocks at this opening were removed. The common blocks were removed at the other two openings and the height of the structure, except at the openings, was increased to one base block and three common blocks. By November, 1956, the pools below the south, middle and north openings in the structure, as a result of a raise in water levels plus digging action, had enlarged and increased in depth from 18 to 30 inches, 28 to 47 inches and 25 to 48 inches, respectively (Plate 7 and Figure 9).

Figure 9. Silver Creek installation #1. Dotted lines show cross-section of stream bottom prior to installation of concrete-block structure in October, 1955. Solid lines show cross-section of stream bottom in November, 1956.

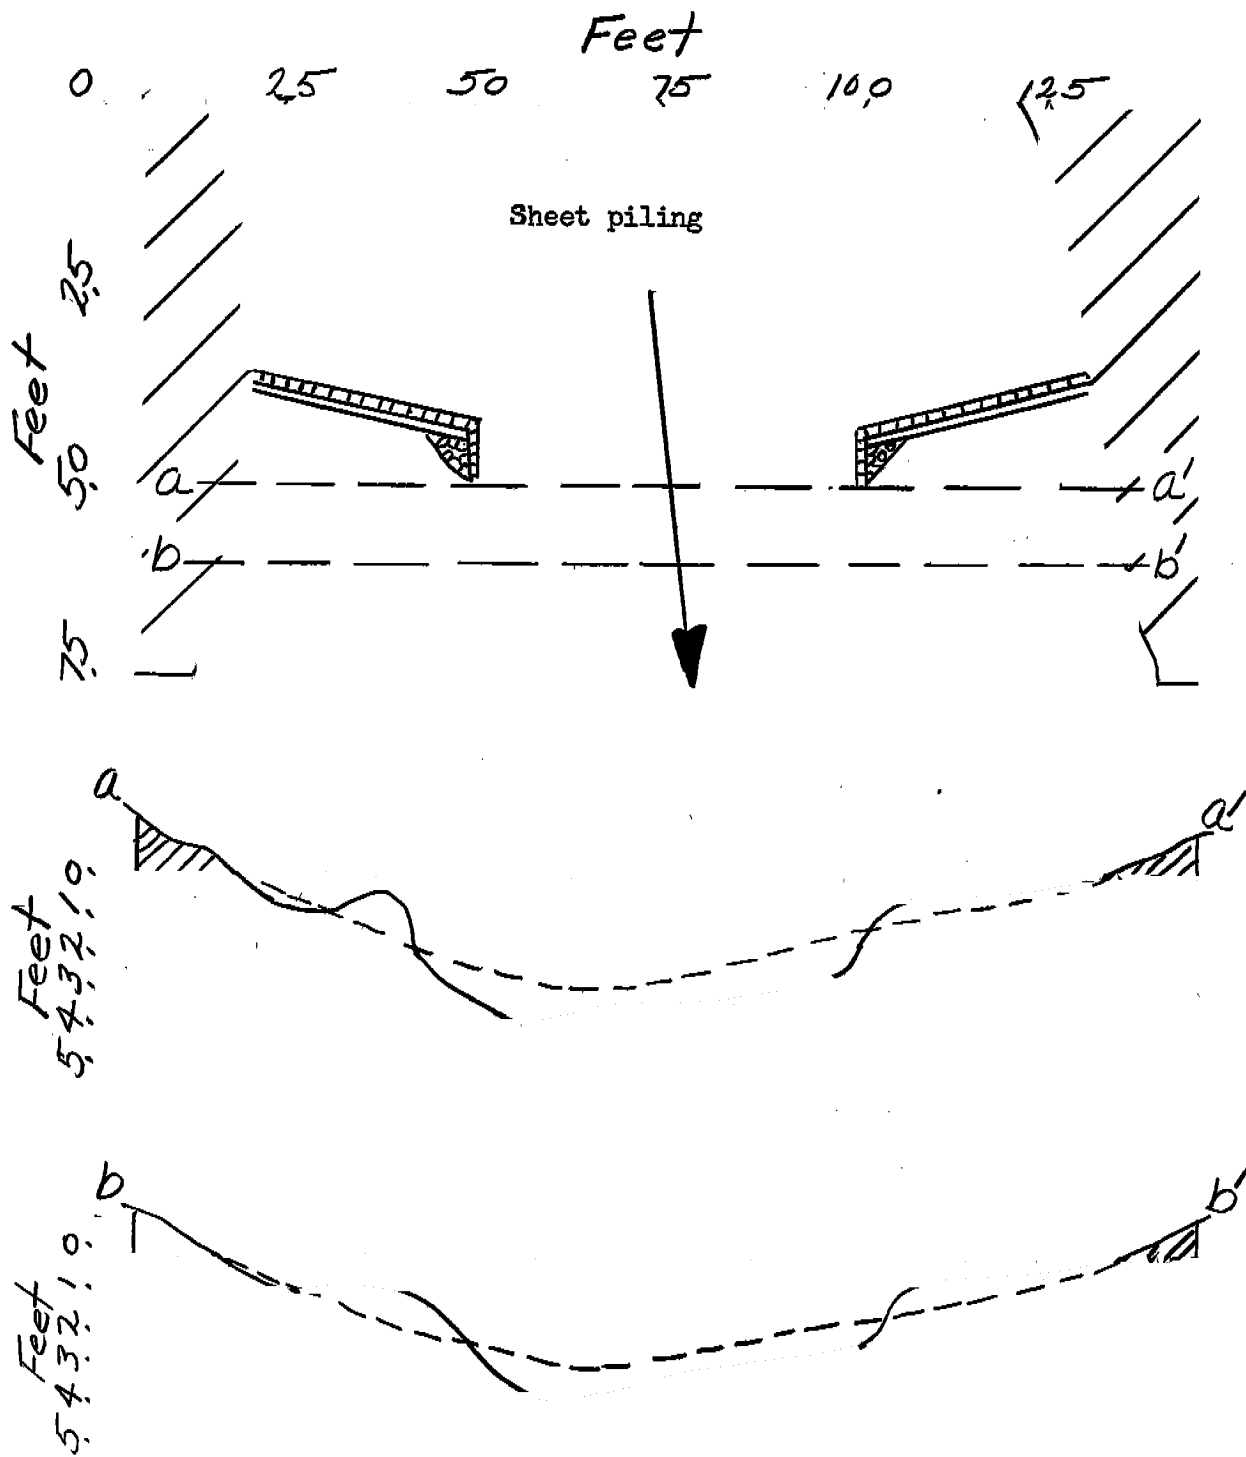
By September, 1956, the pool below this structure, as a result of digging action, had enlarged and increased in depth from 32 inches to 40 inches (Figure 10).

Figure 10. Silver Creek installation #2. Dotted lines show cross-section of stream bottom prior to installation of sheet piling structure in November, 1955. Solid lines show cross-section of stream bottom in September, 1956.

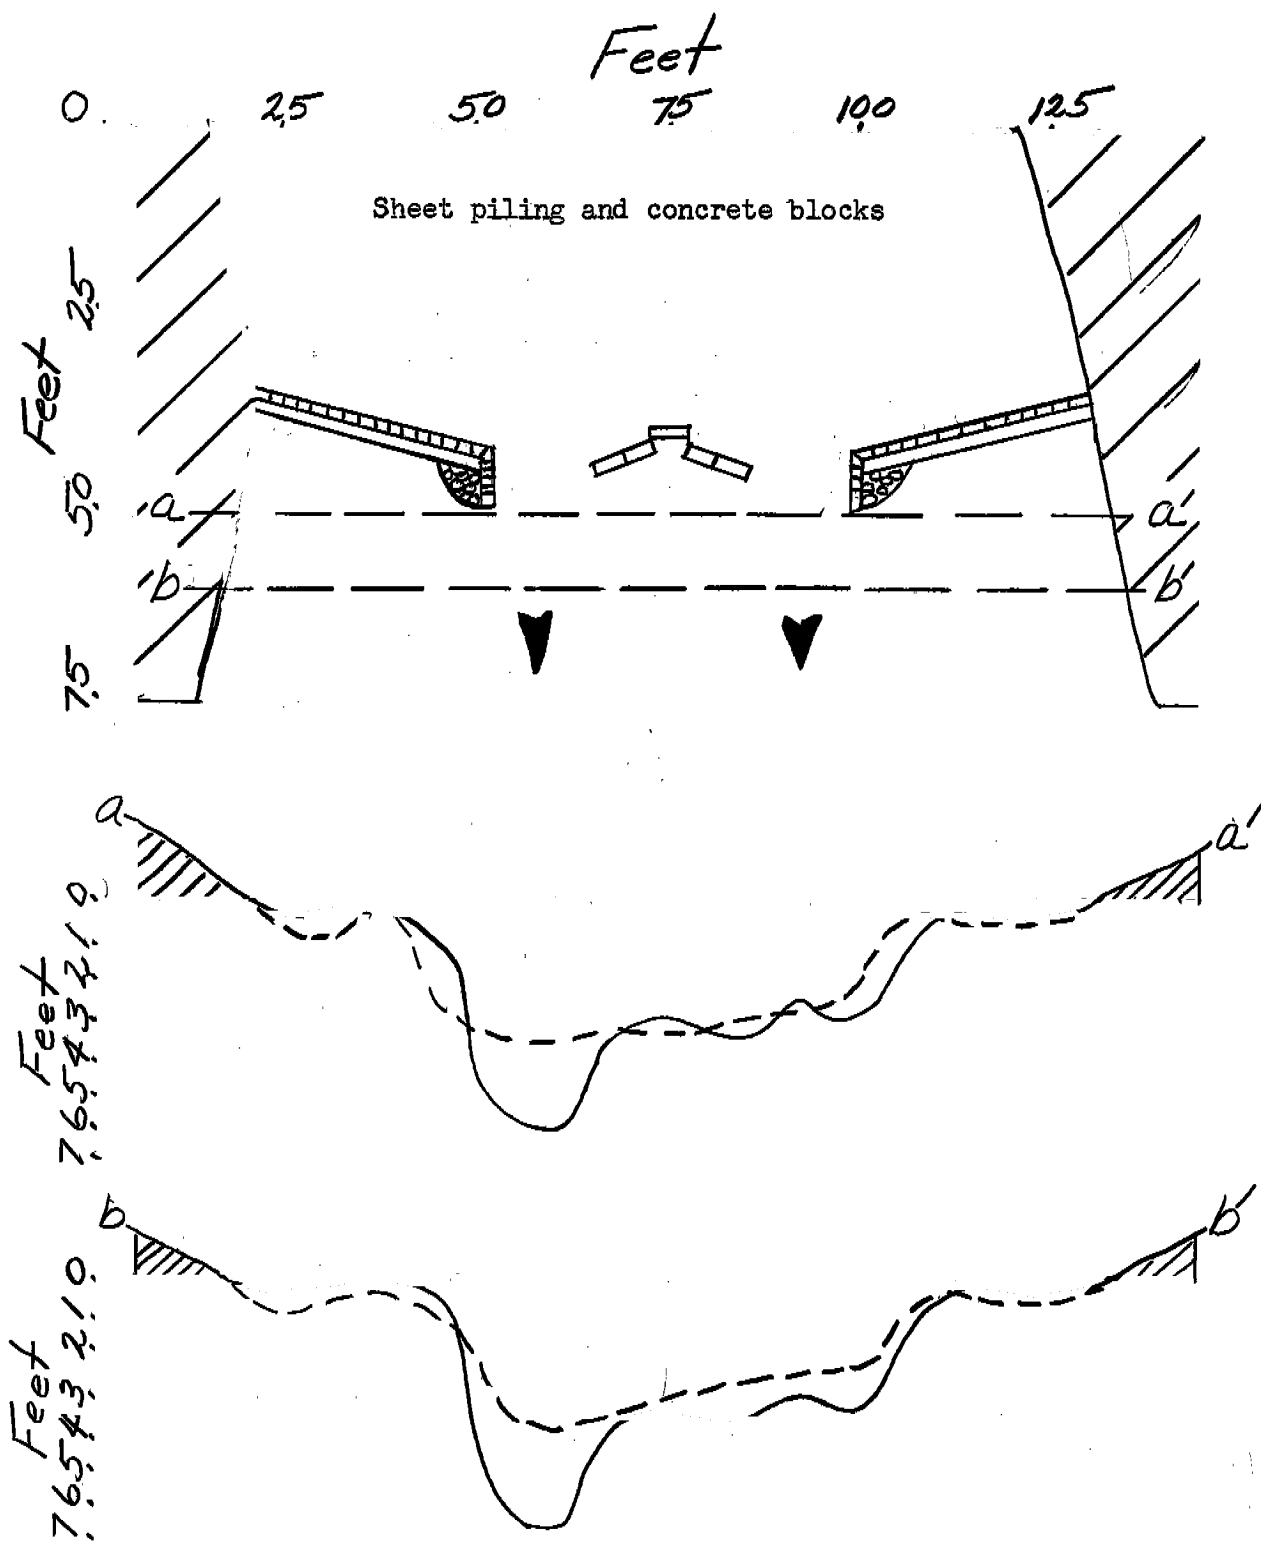
During October, 1956 five rows of common concrete blocks four blocks high, held in position by iron fence stakes, were installed in the opening between the sheet-piling deflectors. By November, 1956, the pool below the structure, as a result of increased digging action, had increased in depth from the original 32 inches to 78 inches (Figure 11).

Figure 11. Silver Creek installation #2. Dotted lines show cross-section of stream bottom in September, 1956. Concrete-blocks were added in October, 1956. Solid lines show cross-section of stream bottom in November, 1956.
